Monitoring Data Record

Project Title: Caviness COE Action ID: 200221216

Stream Name: Tibbs Run DWQ Number: \_\_\_\_\_

City, County and other Location Information: Caviness Site, Randolph County, NC

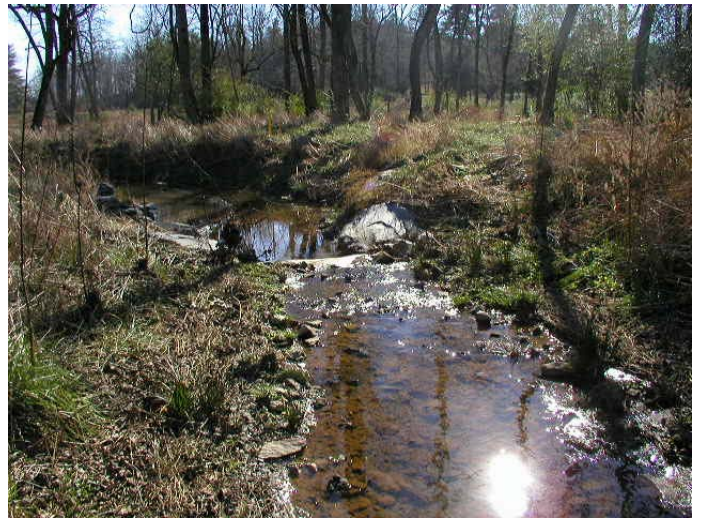
Sta. 51+50 West Branch DS at X-vane & Test Plot #1

Sta. 51+50 downstream photo (water piping through crossvane)

Repairs are being planned by the ONE group.

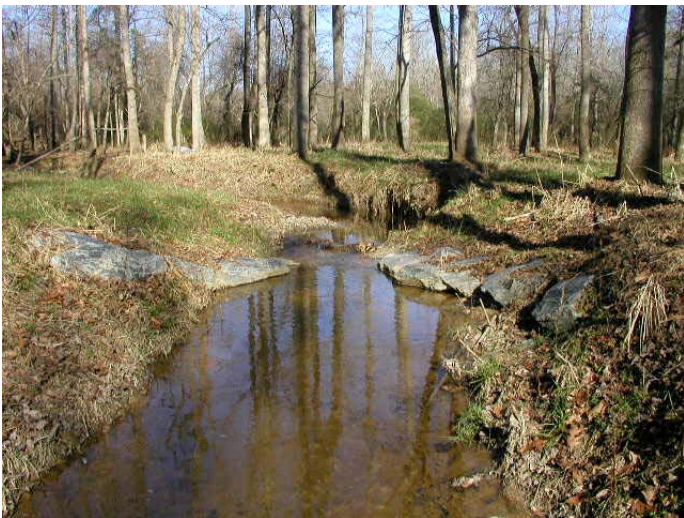
Sta. 29+40 Tibbs Run US at X-vane & pool

Date Inspected	Station Number	Station Number	Station Number	Station Number	Station Number
Structure Type	Sta. 14+34 @ crossvane (upstream photo)	Sta. 14+34@ crossvane (downstream photo)	Sta. 19+17 @ cross vane	Sta. 20+50 @ log vane	Sta. 29+40 upstream from crossvane
Is water piping through or around structure?	Through	No	Through	No	No
Head cut or down cut present?	No	No	No	No	No
Bank or scour erosion present?	No	Yes	Yes	Yes	Yes
Other problems noted?	No	Minor bank erosion on left arm of crossvane	No	Bank has failed but is stabilizing	Bank erosion upstream from crossvane
